MITTELALTERLICHE UND FRÜHNEUZEITLICHE BEFESTIGUNGEN IN DER MÁTRA-REGION

EXKURSIONSFÜHRER

MEDIAEVAL AND EARLY MODERN FORTIFICATIONS IN THE MÁTRA REGION

FIELDTRIP GUIDES

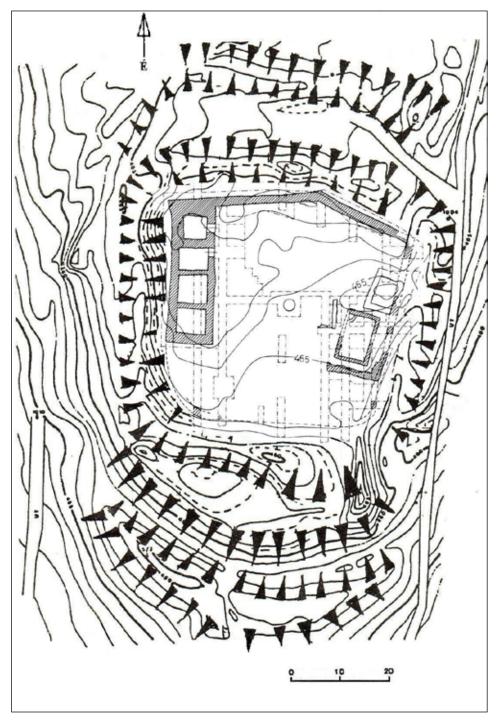
3. Ground plan of the excavated remains of Bene Castle (after J. J. Szabó)

The palace building situated in the north-western corner of the castle includes three chambers. The northernmost with a south-eastern doorway is 4.5×4.5 m large and has thicker walls (3.2-3.7 m) than the other parts of the palace (1.7-1.9 m) and thus it can be interpreted as foundation of a tower. The remains of the burnt timbers and also a burnt door-frame stone excavated inside this tower referred to a devastating fire which possibly caused the final destruction of the castle.

The palace continued to the south with an adjoining 11 m long chamber split in two by an archway roughly at its lateral axis. The entrance was at the north-eastern side opening directly onto courtyard. Charred beams, collapsed and burnt carved stones found in the southern part of the chamber and the fact that the floor in some places had burnt to red also refer to an intense fire. The southernmost part of the palace is a 5.6×6 m large chamber having no traces of ground-floor entrance. Its function is unclear. Some secondarily built-in carved stones were found in the northern wall of the room but no signs that they would have been used for walling up could be traced. A thin burnt layer connected with the destruction of the castle ran along the whole building. The destruction layers of the bu-

A small tower interpreted as a gatehouse was excavated at the north-eastern side of the castle. According to the finds from its remains it can be dated to 15th C. Its uncovered walls somewhere are still 1.5 m high. An almost 2 m deep and 5.3×4.2 m large rock-hole was found within its walls most probably used as trou-de-loup or drawbridge pit. Just slight remains of ground walls of another building were unearthed south-westward of gatehouse. Its inner size is 8.9×5.4 m, foundations were made of stone but basing on architectural features the upper part was timber-framed. Some traces of a former fireplace were identified in the north-western corner of this building. The hearth of the fireplace was of bricks and it was surrounded by a carved stone wall. Most probably another fireplace was also in the south-eastern corner of the same building but only remains of the burned earthen hearth and some random carved stones were found. This building of still unknown function according to the archaeological material from its destruction layers can be dated to 13–14th C.

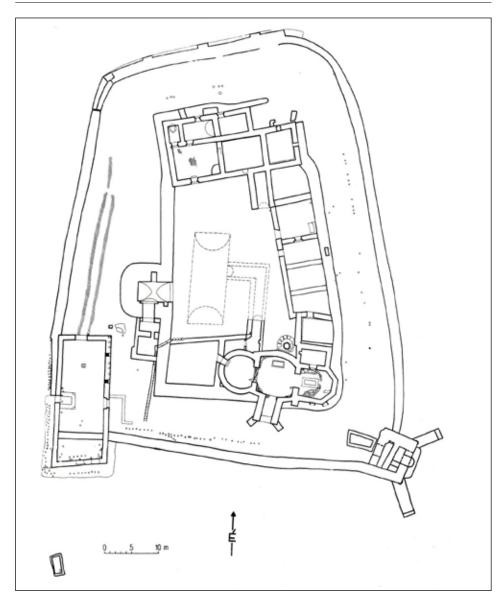
2. Kisnána. The ground plan of the castle (After N. Pámer)

The south-western chamber was the largest in the palace. It had a tile floor and a fireplace in the south-eastern corner. The north-western small room included an inner well. Next to this tiny room was a larger one, barrel vaulting and white plaster work of which have partially survived. A latrine was accessible from the eastern chamber of the northern line. The central and the eastern chambers of the southern line remained only on the cellar level. They had originally a flat ceiling but later it was replaced by barrel vaults.

Kisnána first appears as a fortified site in 1445 when written sources mentions John Kompolti's brand new castle. Slight traces of some wooden fortification around the castle hill were discovered during the excavations. However, it does not seem too likely that the newly built castle would have had only some palisade in the mid 15th C. Most probably the inner stone wall of the castle was finished until 1445 and perhaps the curtain wall as well. The wooden construction could have served as an earlier defensive system or as a later reinforcement of the stone walls (e.g. after the first Turkish siege in 1543). Its dating is quite uncertain. Both the inner and the curtain walls were approximately 2-2.5 m thick. The inner wall was originally 8 m high, which is well visible on the south wall of the inner gate-

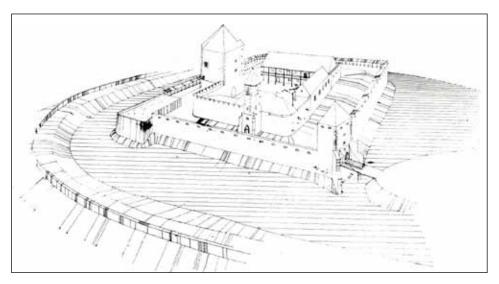
3. Kisnána. Virtual reconstruction of the castle c. 1500 (Ferenc Erdei)

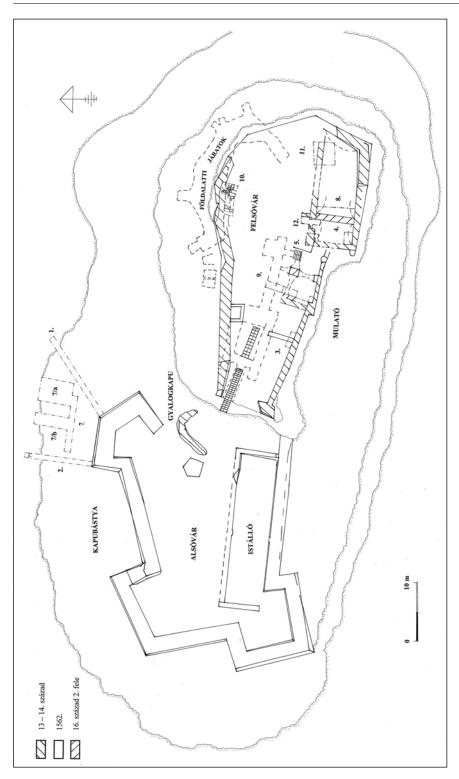
2. Ground plan of Sirok Castle

In Sirok the upper castle is dated to 13-14th C. We found proof of that in the south-eastern corner of the upper castle there had been a cellared palace wing laid out on an east-west axis, to which the openings positioned high up on the south-eastern corner of the upper castle could have originally belonged. The northern walls of this palace are under the ground level now. Due to the lack of larger excavations we still do not know if there are different periods represented in the upper castle.

It was in 1562, when the lower castle with pentagonal bastions was built by Kristóf Országh. It is interesting, that in the western walls of the lower fortress Romanesque fragments of cornices were built in. These pieces are dated to 13th C and had belonged to a church not far from the castle. Actually, these pentagonal bastions, which looked like modern Italian fortifications, were much different from them. What was missing? These bastions did not form a system, as due to the shape of the plateau the ground-plan of the lower castle could not be symmetric, though the crenels, which were suitable only for rifles, were perfectly directed to the curtain walls, as usual. Inside wooden structures, floors, watchpathes were made; their remnants are visible on the surfaces of the walls by in form of holes.

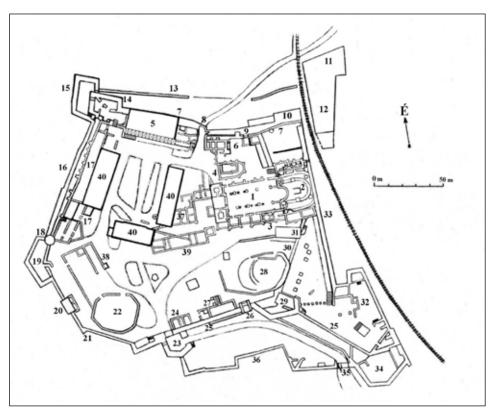
1. Plan of Eger Castle as it is at present (showing survived and excavated buildings) 1. Cathedral of St. John; 2. 14-15th C presbytery; 3. Rotunda; 4. St. Stephen's Church; 5. Bishop's Palace; 6. Buildings excavated along the inner side of the northern wall; 7. Northern curtain walls of the mediaeval castle; 8. The northern Gatehouse of the present day Castle; 9. The Timber Gate (Porta Lignea); 10. Alexander (Sándor) Bastion; 11. Zárkándy Bastion; 12. North-eastern Bastion; 13. Northern Rampart; 14. Gaol (Tömlöc) Bastion; 15. Earth Bastion; 16. Western Rampart; 17. Buildings behind the northern rampart; 18. A mediaeval tower; 19. Dobó Bastion; 20. Smiths' Tower; 21. South-western Rampart; 22. South-western Cannon Hill; 23. Varkoch Gate; 24. An 18th century three-chambered house; 25. Southern Rampart; 26. Hippolit Gate (Southern mediaeval gatehouse); 27. Building complex along the inner side of the southern rampart ("Great Gothic Building" and an annex with an oven); 28. South-eastern Cannon Hill (Belle Bastion); 29. Gregory (Gergely) Bastion; 30. Eastern inner wall (Eastern wall from 1540s of the inner castle); 31. Dark (Setét) Gate; 32. South-eastern Bastion; 33. Eastern Rampart (Eastern wall from 1570s of the inner castle); 34. Turkish Gate Defence (Turkish Garden); 35. Lower Gate; 36. Southern Outer Rampart; 37. Governor's Palace; 38. Hospital; 39. Barracks; 40. Buildings of the Castle Museum

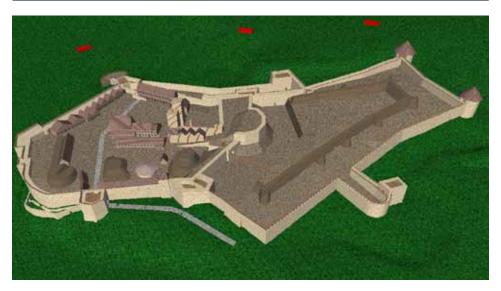
4. An attempt to reconstruct Eger Castle on the base of Feraboscho's plan, 1568

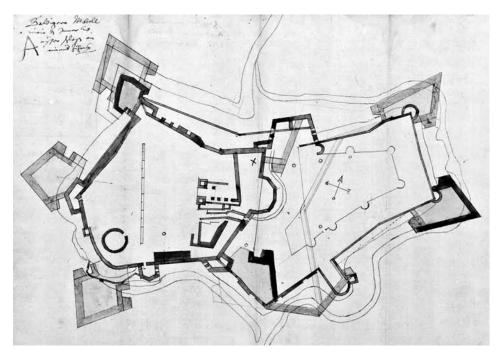
9. Ottavio Baldigara's Plan 'A' to reinforcement of Eger Castle, 1572

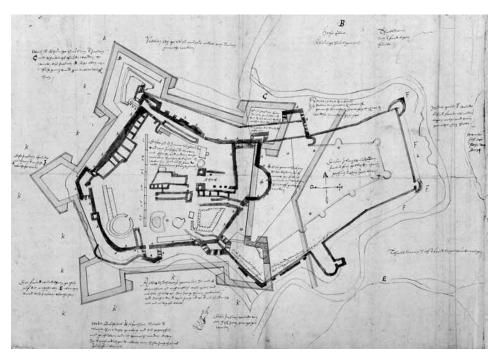
10. Ottavio Baldigara's Plan 'C' to reinforcement of Eger Castle, 1572

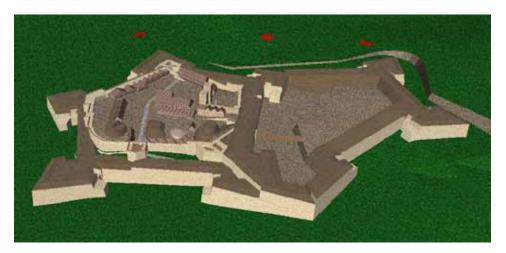
11. An attempt to reconstruct Eger Castle on the base of Baldigara's plans, 1572

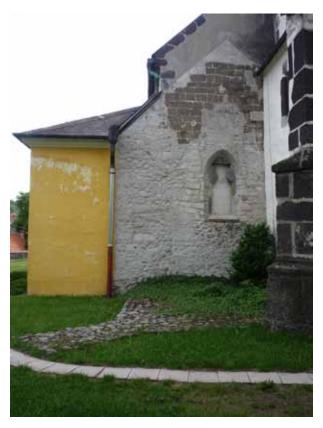
4. Gyöngyöspata. The parish church. Remains of the earliest church

ly enlarged by its possessors. First it was rebuilt in the 13th century with adding a western tower, a chapel and a sacristy. (The chapel dedicated to St. Andrew was demolished in the mid 18th C.) In the 14th century Demeter of Nekcse made the church rebuilt, prolonging the nave 3 metres to the east and constructing a new presbytery with straight termination. A fresco depicting the apostles and the birth of Virgin Mary remained from the time of this reconstruction behind a secondarily built in roman arch. This fresco decorated the northern wall of the new presbytery. By the end of the 14th century the church was extended again and transferred into a three-aisled building. The frescoes on the southern wall showing the scenes from Life of Jesus of the church can be connected with this period. The dating of the frescoes basing on their style can be

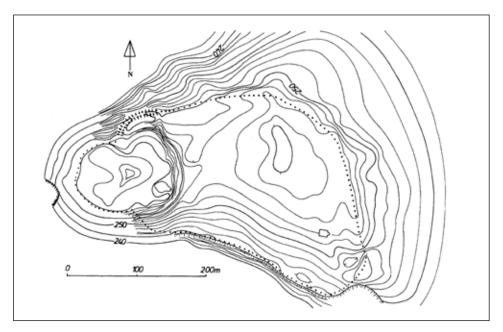
7. Gyöngyöspata. Plan of the fortifocation (after Nováki et all. 2009.)

The excavations could not give the precise dating of the fortification yet. According to the observations made during the research in 1960's, the ditch was prepared first. Then, 1.5-2 m away from the inner edge of the ditch a 0.8-1 m long stone wall with clay mortar

The dating of the rampart is also problematic. Béla Kovács supposed that the building method of the fortification is a 10th-C technology and accordingly he dated the rampart to the mid 10th C. On the one hand the published archaeological material (mostly ceramics) does not allow making a precise dating within 10-11th C, on the other hand the theory was based almost exclusively on the statement of Anonymus' *Gesta Hungarorum*. Due to the problematic dating and unreliability of the *Gesta* this theory cannot be accepted. Presently the construction of the fortification basing on the archaeological finds can be dated to late 10th early 11th C.

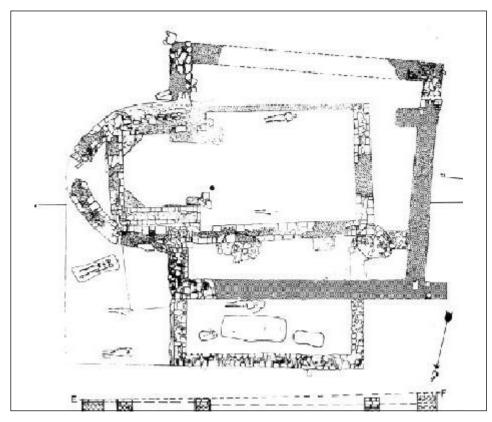
8. Gyöngyöspata. The ground plan of the St. Peter's church (after Szabó J. Gy. 1985.)

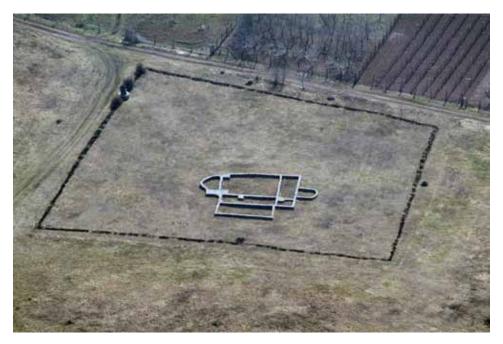
9. Gyöngyöspata. The reconstructed foundations of the St. Peter's church.

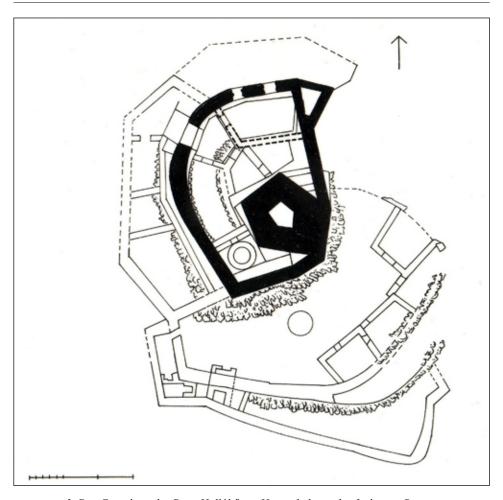
3. Der Grundriss der Burg Hollókő mit Hervorhebung der frühesten Bauten

in Ungarn zu bezeichnen. Er besaß nur einen Hocheingang im zweiten Obergeschoß, wo
zwei Kragsteine auf das ehemalige Zugangssystem hinweisen. Seine kleine Innenräume
mit Holzdecken wurden nur durch schmale Schlitzfenster beleuchtet. Die Mauerdicke

Nach der zuletzt genannten Auffassung wäre im späten 13. Jahrhundert nur ein kleines Gebiet nördlich des Bergfriedes unbebaut gewesen – eine Treppe aus der Richtung des

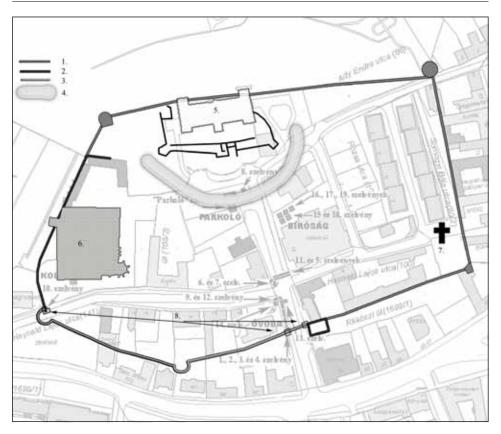
1. Die mittelalterlichen und frühneuzeitlichen Befestigungen von Szécsény auf dem heutigen Stadtgrundriss

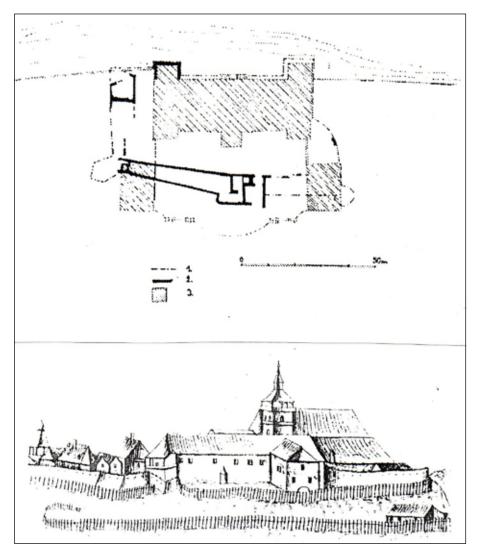
3. Das Schloss und das Franziskanerkloster von Szécsény vom Norden auf einem Stich des 17. Jhs. und die vor 2005 bekannten mittelalterlichen Teile des Schlosses (nach Majcher 1999.)

Die bisherigen, meist begrenzten und teils noch unveröffentlichten archäologischen Untersuchungen und die partiellen Mauerforschungen konnten die Baugeschichte des Schlosses noch ungenügend klären. Wir wissen aber, dass das heutige Schloss unter der Verwendung von bedeutenden, spätmittelalterlichen Bauteilen entstand, die aus den ab der Mitte des 15. Jhs erwähnten, herrschaftlichen Bauten stammen könnten. Besonders im turmartig ausgebildeten (und vielleicht mit dem 1596 erwähnten Steinturm zu identifizierenden) NW-Risalit und im länglichen Nordtrakt des Gebäudes konnten – bei letzterem vor allem im Kellerniveau – höhere, mittelalterliche Mauerteile, darunter einfache Fenster- und Türöffnungen beobachtet bzw. freigelegt werden. Sie weisen auch Spuren von mehreren Bauperioden auf, deren genauere zeitliche Einordnung innerhalb des

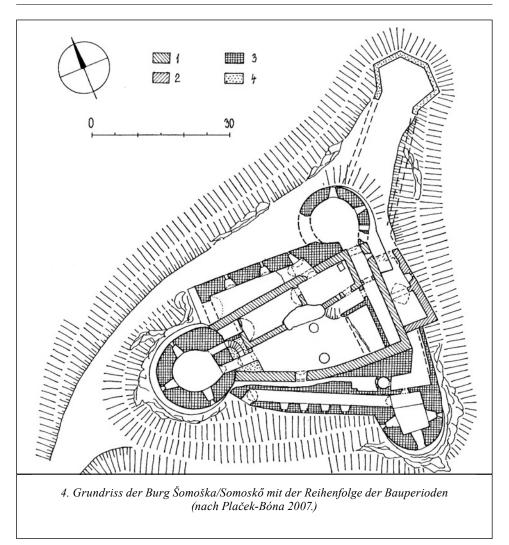
Die älteste Burg war nicht besonders geräumig und ist vollkommen durch die Renaissance-Fortifikation verdeckt. Ihre Form war dreieckig und in der zum Zufahrtsweg gerichteten, scharfen Westspitze wurde ein Batterieturm errichtet. Er hat die Gestalt eines verformten Kreises mit einem Durchmesser von 16,5 m, die Mauern sind mehr als 3,5 m stark. Dadurch galt er als eine der besten Anlagen zur Unterbringung von Geschützen. Zwei andere Wehrbauten befanden sich in den restlichen Ecken der Anlage, im Erdgeschoss der nordöstlichen Ecke lag das Tor. Der südöstliche, halbzylindrische Batterieturm mit im Grundriss rechteckförmigem Innenraum liegt dicht an einer merkwürdigen Kasemattenbefestigung. Die Gänge und Räume mit Tonnengewölben in den zwei Geschoßen waren hier durch eine Spindeltreppe verbunden. Der einzige Zugang aus dem Burgkern führte durch einen schmalen Gang. Eine ähnliche Anlage war auch entlang der Nordfront der Burg zu finden. Die sich nach oben verjüngenden Wehrbauten bestehen aus einheimischem Basalt und der Schrägsockel war vom Körper der Türme durch ein abgerundetes Sandsteingesims optisch abgesetzt.

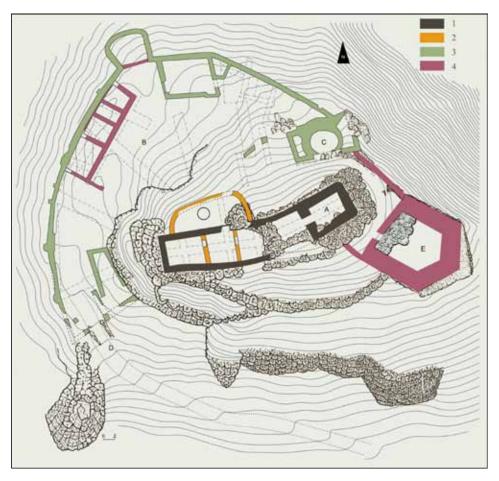
1. Der Grundriss der Burg Salgó mit der Reihenfolge der Bauperioden (1-4.) A: Der Turm der oberen Burg, B: Die untere Burg, C: Die große Zisterne, D: Das äußere Burgtor, E: Der Kanonenturm

Aus diesem Grund wurden Teile der Burgruine im Jahre 1938 nach den Plänen von Géza Lux als Aussichtspunkt umgebaut – aber damals natürlich noch ohne archäologische Forschungen. So diente der Stumpf des Turmes, der über dem höchsten Punkt des Bergrückens stand, bis zum Ende des zweiten Weltkrieges als Aussichtsturm, bis er später zerstört wurde.
